Florida State University

RESEARCH FINAL REPORT

Improving Cutaway Bus Safety for Aging Passengers

December 2014

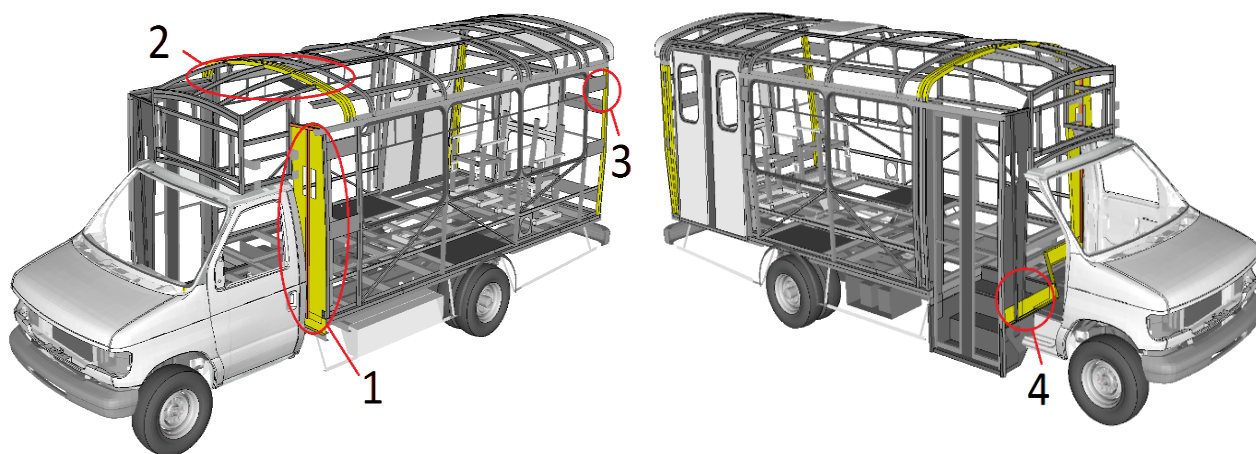
Figure 4.2. Areas for improvement - side panel (1), roof bow (2), back wall holes (3), and stairway (4).

A series of simulated ECE R66 rollover tests was then conducted using the updated FE model of the bus. Champion Bus had independently improved the front cap area design several years prior, which improved its rollover performance compared to the previous CIAL FE model. These design revisions created a very good base for further development of the designed bus. The simulated rollovers were analyzed in order to determine areas with excessive deformation. Specific parts within these high deformation areas were then identified in order to be used as targets for structural improvement. The four most critical areas were chosen (fig. 4.2):

- The side panel behind the driver's seat (1).
- The front roof bow structure (2).
- The position of the openings in the tubes in the back wall (3).
- Reinforcement of the staircase z-channel (4).

An optimization study was conducted using LS-OPT software to determine the most efficient methods of reinforcing the indicated elements. After a series of additional numerical rollovers and consultation with a Champion Bus engineer, the improved bus design was finalized and sent to Champion Bus, Inc. for implementation. The list below describes these changes in detail:

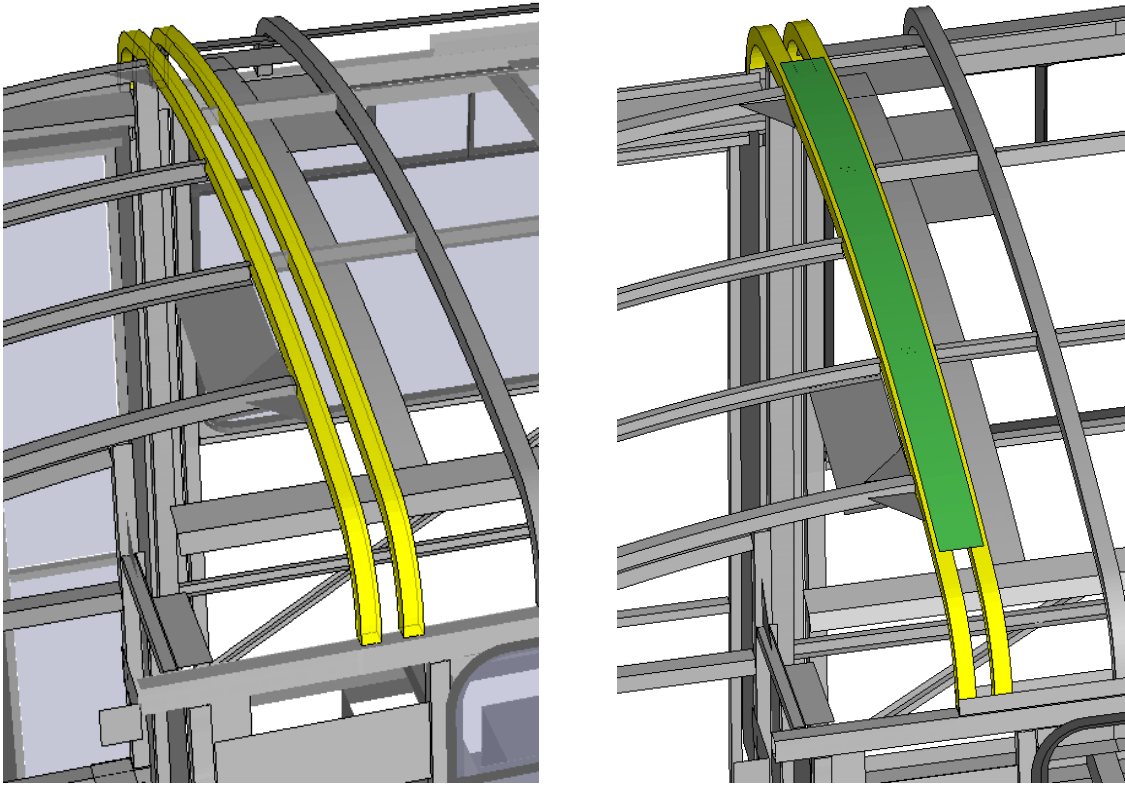
Figure 4.4. Original front roof bow structure (left), proposed 11 gauge steel plate (right).

2. **Front Roof Bow Structure** - The original front roof bow structure (fig. 4.4, left) underwent extensive buckling during the roll-over test. The agreed upon modifications were to add an 11 gauge steel plate, 3.5 inch wide and 67 inches long, on the top of the two front roof bows as indicated in fig. 4.4 (right, green). The plate should be welded from each side to the roof bows with at least a 1 inch weld every 13 inches.

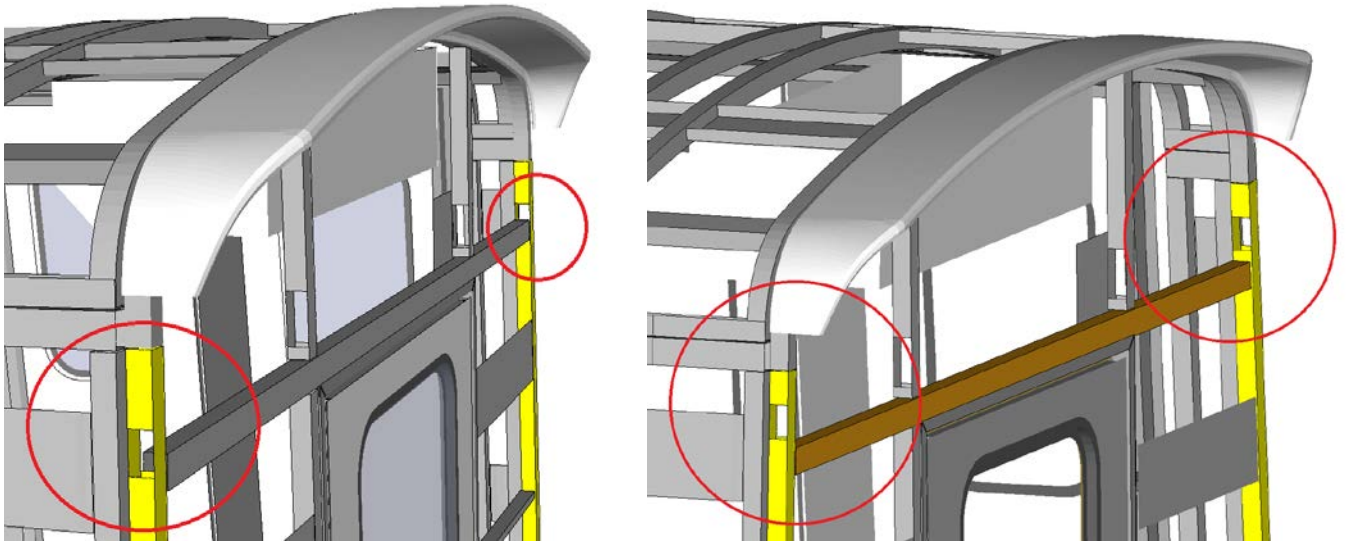
Figure 4.5. Position of cable pass through in the original back wall structure (left) and in the revised design (right).

3. **Back Wall Column Openings** - The position of the openings cut into the outer vertical columns of the original back wall structure are shown in fig. 4.5 (left). It was agreed that the position of these holes should be changed so that there is no overlap with the horizontal member. Fig. 4.5 (right) shows the new position of the openings. They are cut 1 inch above the horizontal member of the back wall structure (indicated in brown). The relocated openings maintain their original dimensions of 1.5 in by 2.5 in.

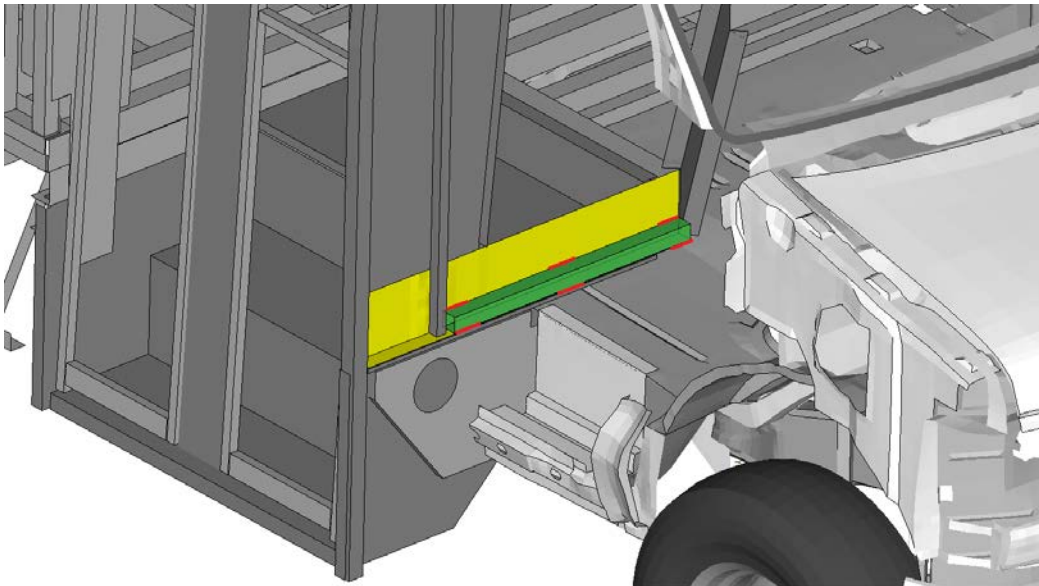
Figure 4.6. Position of the z-section (yellow) which was reinforced by a horizontal tube (green) and welded (red).

4. **Reinforcement of the Stairway Z-channel** - During the numerical rollover analysis, the z-section with the cut off top lip located near the staircase undergoes large deformations due to concentrated loads from the frontal ring section. It was agreed that this section should be reinforced. The location of this element is shown in fig. 4.6 (yellow). The solution was to add a horizontal square tube (11 gauge, 1.5" x 1.5' x 23.5") on top of the lower flange of the indicated z-section. This element (fig. 4.6, green) is welded to the bottom flange and the web of the z-section with at least 2 in. welds every 9 inches (red lines).

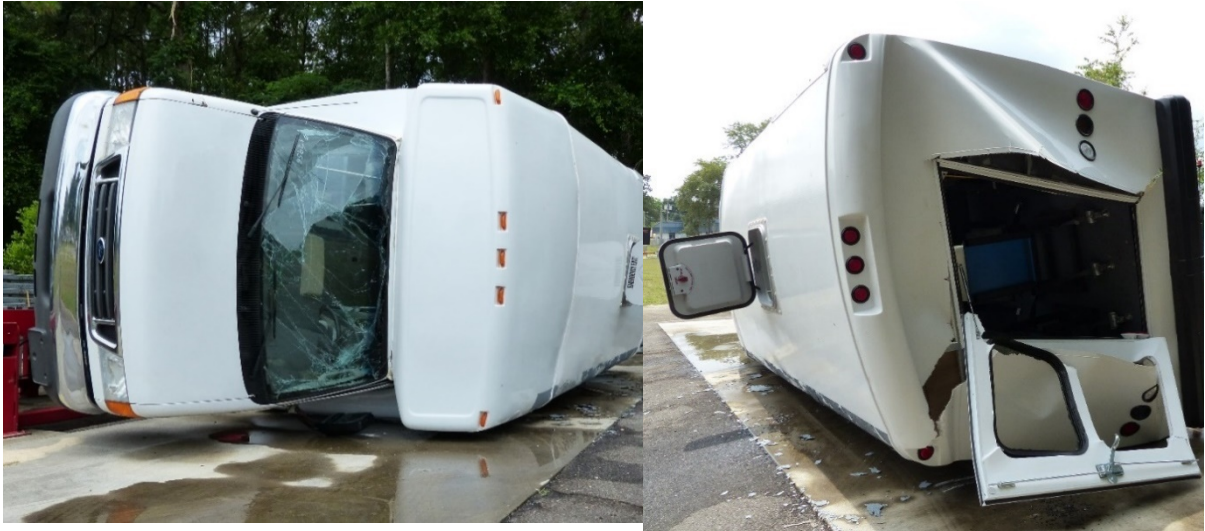
Figure 7.1. Front and rear view of the Champion prototype bus after rollover.

approximately 44 degrees) and fell to the concrete slab located 31.5 in. below the starting plane of the tilt table. Fig. 7.1 shows front and back views of the bus after the rollover.

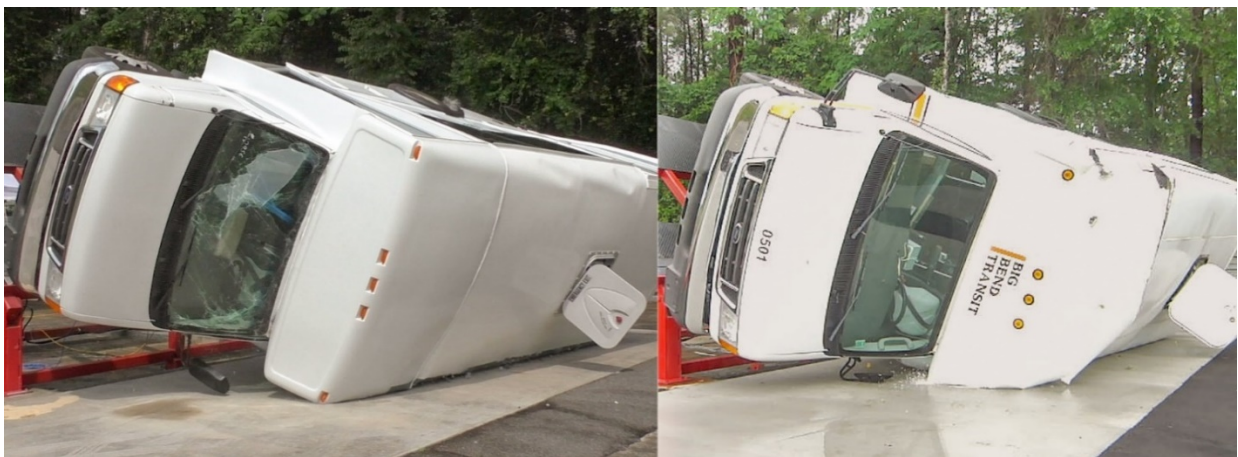
Figure 7.3. Front view at 0.25 seconds after impact, 2014 rollover (left) and 2011 rollover (right).

The results show that the frontal structure of the bus body reaches a max DI of <0.6 and easily passes. This result is a significant improvement over the bus rolled over in 2011, which had a maximum DI of >1.2 . The improvement is also very visually apparent, as shown in fig. 7.3 that compares the two tests at 0.25 seconds after impact.

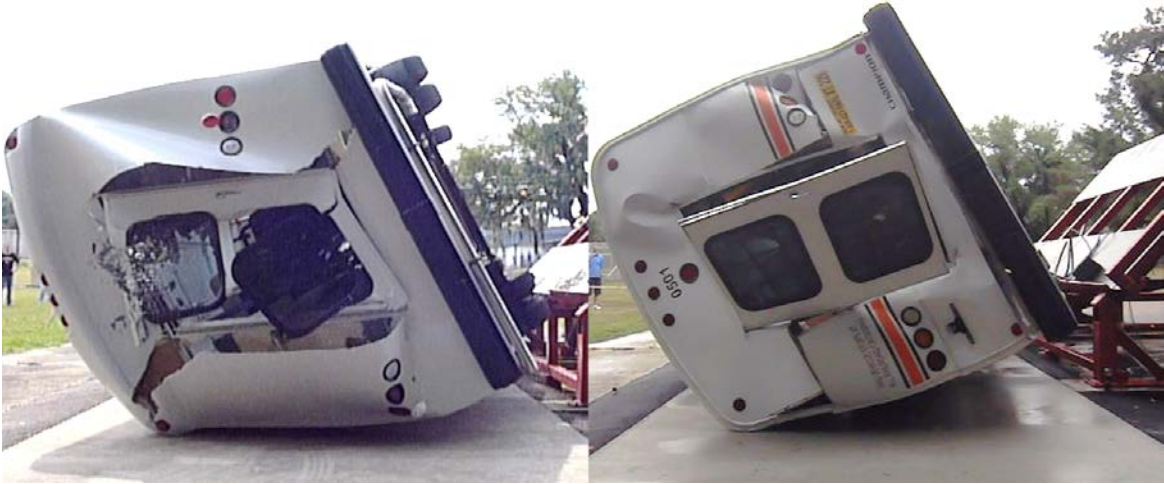
Figure 7.5. Rear view at .25 seconds after impact, 2014 rollover (left) and 2011 rollover (right).

The results for the back wall structure of the bus, however, differ substantially from what was predicted by the FE simulation and from the 2011 rollover. As can be seen in fig. 7.4 the back wall Deformation Index reaches a maximum value of $DI > 1.3$ indicating substantial intrusion into the residual space and failure of the rollover test.

The relatively poor performance of the 2014 bus back wall when compared with the 2011 test is easily seen in fig. 7.5 which shows both buses at 0.25 seconds after impact. Though it was expected that the back wall might perform slightly worse than the 2011 test due to the stronger front structure, a test failure was not anticipated. In order to determine the reasons for the deviation from the predicted results a post-test analysis was conducted on the bus structure.

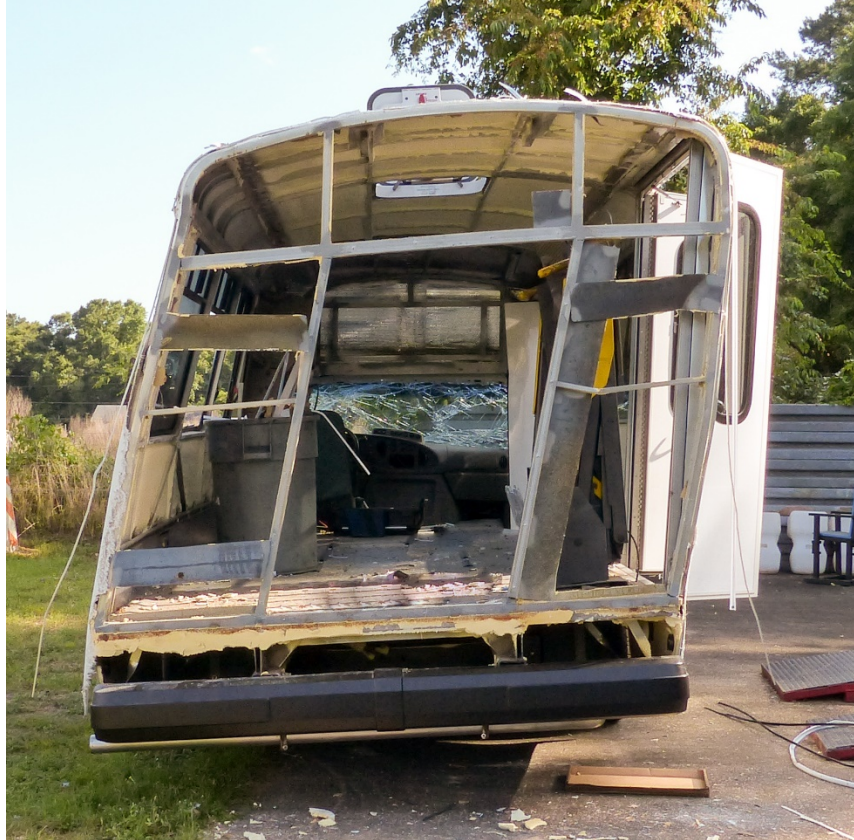
Figure 8.1. Back wall structure with rear skin removed.

The prototype bus was stripped of its external skin and other non-structural components in order to allow a direct investigation of the body frame as shown in fig. 8.1. The frame was then checked for compliance with the design drawings obtained from Champion, Inc. A major difference between the tested bus and the FE model used in the rollover simulation was the substitution of a Fiber Reinforced Polymer (FRP) rear cap for the bus body. The skin used in all past FE simulations, including the optimization runs, was modelled as a plywood-metal sheet material reinforced by a spray-on polyurethane foam and screwed directly to the back wall frame. A small separate extended ABS cap was attached at the top of the back wall. This was replaced with a new, one piece FRP rear cap wraps around the back wall and is screwed to the sidewall. Both of these can be seen in fig. 7.5, where the 2014 rollover uses the FRP cap and the 2011 rollover uses the plywood/metal skin. The combination of the different attachment method of the FRP cap (to the sidewall) and the brittle failure mode of the FRP, together provided significantly less reinforcement of the back wall frame when

compared to the previous style back wall. The importance of this change in the back wall skin was underestimated in advance of the test.

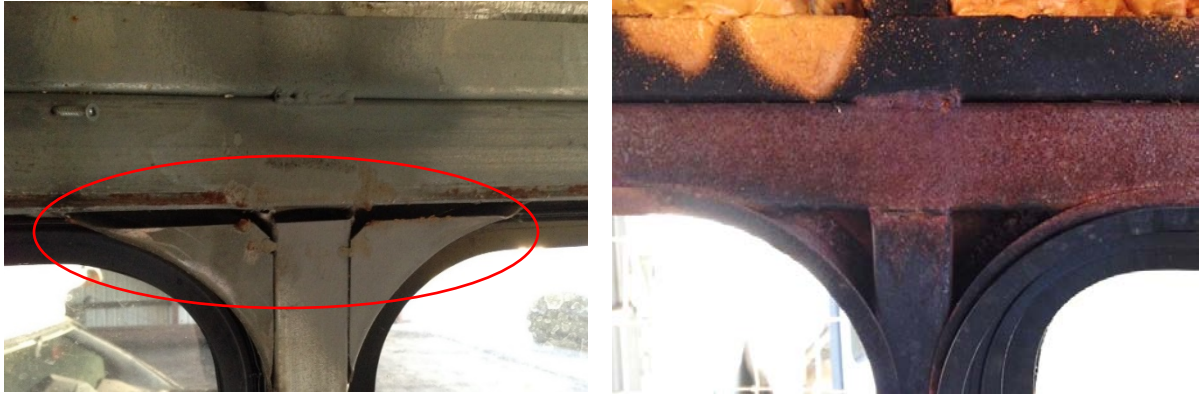
Every sidewall column tube was missing the inside face weld where it connects to the sidewall cantrail (not fully welded). The result on the road (driver) side was a joint that was too weak to withstand the moment load applied during the rollover and that opened approximately 0.25" along each column down the entire sidewall. This is contrasted with the performance of the same joint 2011 rollover in fig. 8.2 where it can be seen that the four sided weld on the same column/cantrail connection remained completely intact.

Figure 8.2. Column to cantrail joint not fully welded on 2014 bus (left) vs. fully welded on 2011 bus (right).

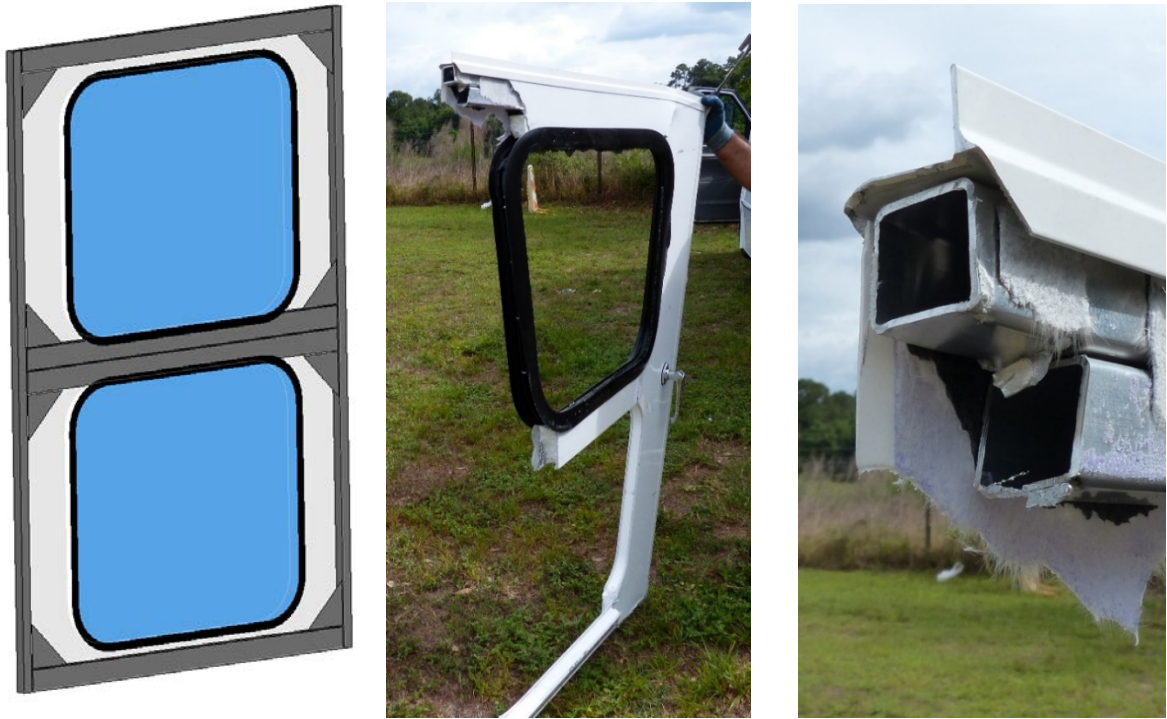
The rear door contributes to the strength of the back wall during the initial portion of the rollover induced deformation. Because no new drawing was provided for this door its design was assumed to be the same and was carried over from the previous FE model. The modeled door was built from 11 gauge aluminum tubes - 2"x 1" at the top, bottom, and middle with 1"x 1" tubes on the sides and 11 gauge gussets at the corners, fig. 8.3. The door on the test bus also used 11 gauge aluminum tubing but with doubled 1"x 1" tubes at the top and bottom and no center tube(s) or gussets. The insufficient welding of the test bus door tubing was not able to withstand any dynamic loading. Together the reduced structure and insufficient welding resulted in a much weaker door that, when compared to the previous design, was capable of dissipating only a fraction of the energy during rollover before complete structural failure.

Figure 8.3. Door model used in the FE model (left), test bus rear door showing the missing aluminum center tubes and gussets (center), and close up of upper door tubes showing insufficient welding (right).

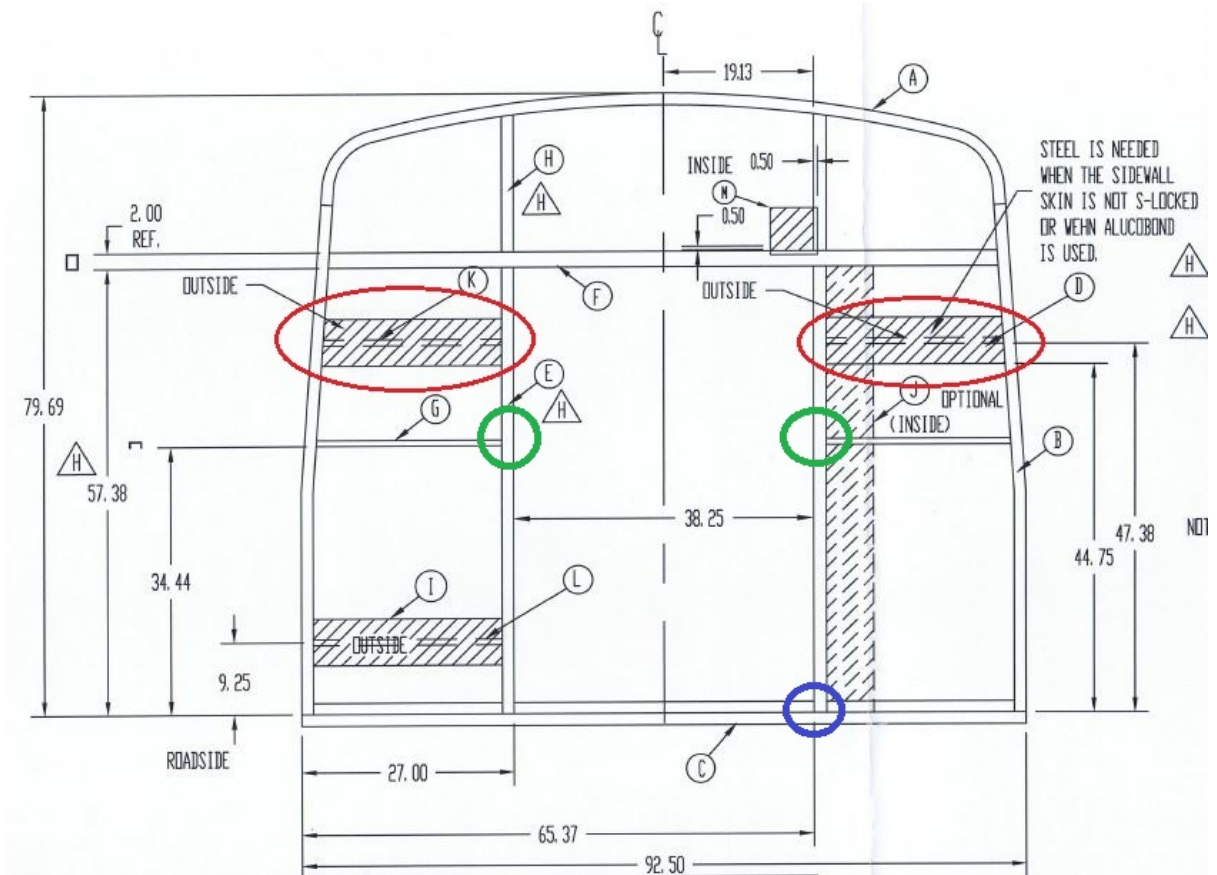
The back wall was missing the uppermost horizontal channel sections, which, according to the drawings, were to be located behind the upper horizontal steel plates (fig. 8.4 - red). The horizontal channels located in the middle of the back wall were included but were welded only on the bottom (fig. 8.4 – green and fig. 8.5 right) which resulted in them functioning as a hinge and unable to provide any resistance to moment loading. Nearly all back wall tubing connections were insufficiently welded, with welds on only three (or sometimes two) sides. Fig. 8.5 and fig. 8.6 show some examples of these connections.

Figure 8.4. Back wall drawing with indicated missing elements (indicated in red) and insufficient welds (green, blue).

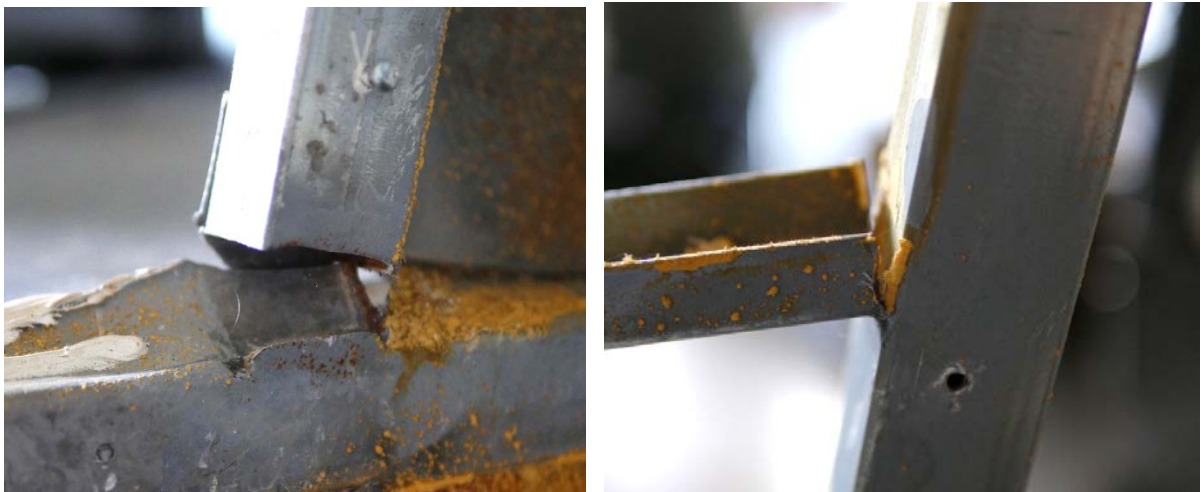
Figure 8.5. Insufficient welding on back wall column to floor (left) and horizontal channel to column (right).

The back wall column openings discussed in the Improve Bus Rollover Crashworthiness section (#3) above were not cut into the back wall column tubes. This can be seen in fig. 8.6 (left) above in which the opening should have been visible in the column tube just above the horizontal tube.

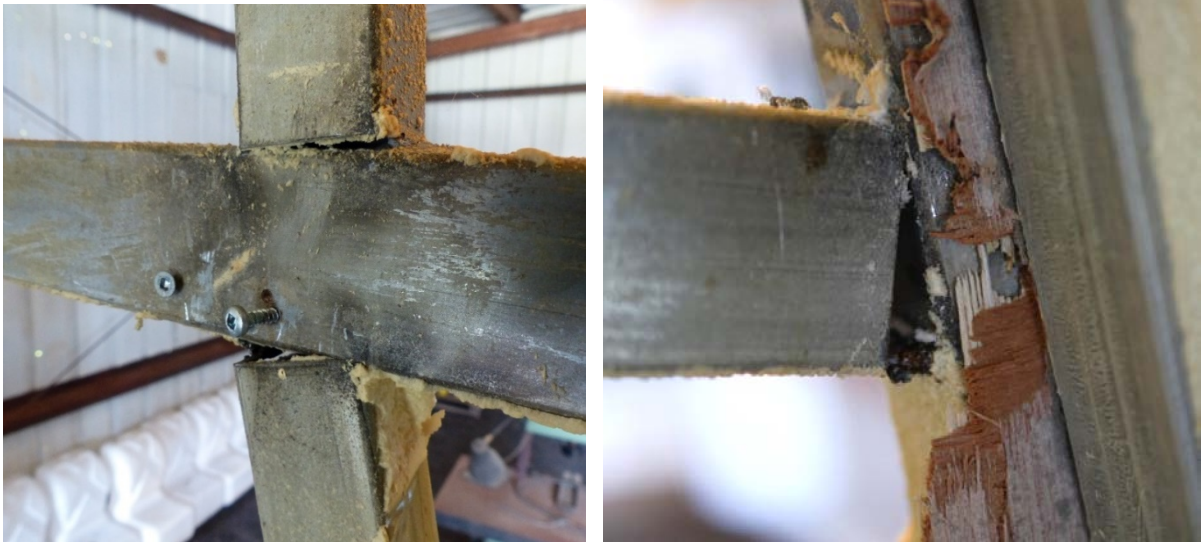
Figure 8.6. Insufficient welding on back wall middle column to horizontal tube (left) and horizontal tube to side column (right).
