Florida State University

RESEARCH FINAL REPORT

Improving Cutaway Bus Safety for Aging Passengers

December 2014

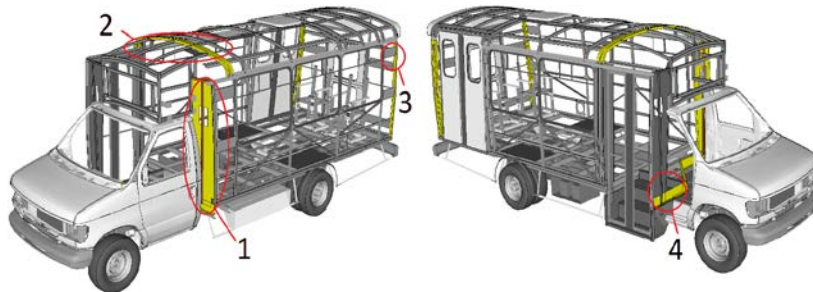
Areas for improvement - side panel (1), roof bow (2), back wall holes (3), and stairway (4).

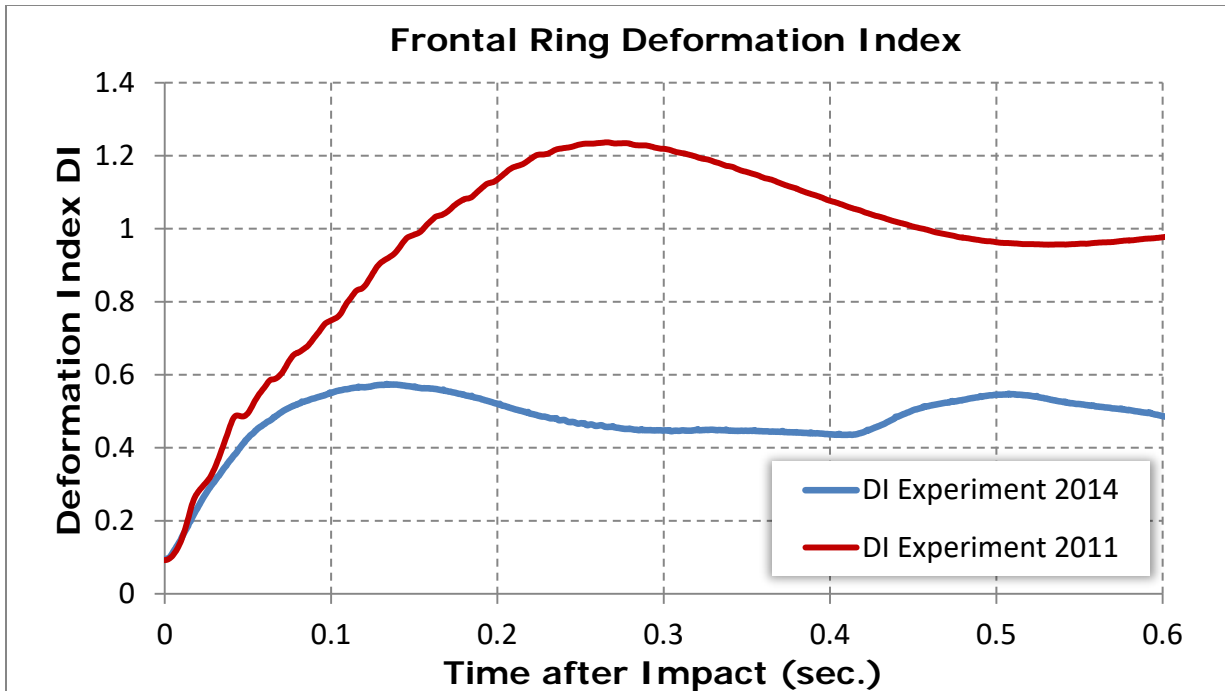
Figure 7.2. Frontal ring deformation index versus time.

The results show that the frontal structure of the bus body reaches a max DI of <0.6 and easily passes. This result is a significant improvement over the bus rolled over in 2011, which had a maximum DI of >1.2 . The improvement is also very visually apparent, as shown in fig. 7.3 that compares the two tests at 0.25 seconds after impact.

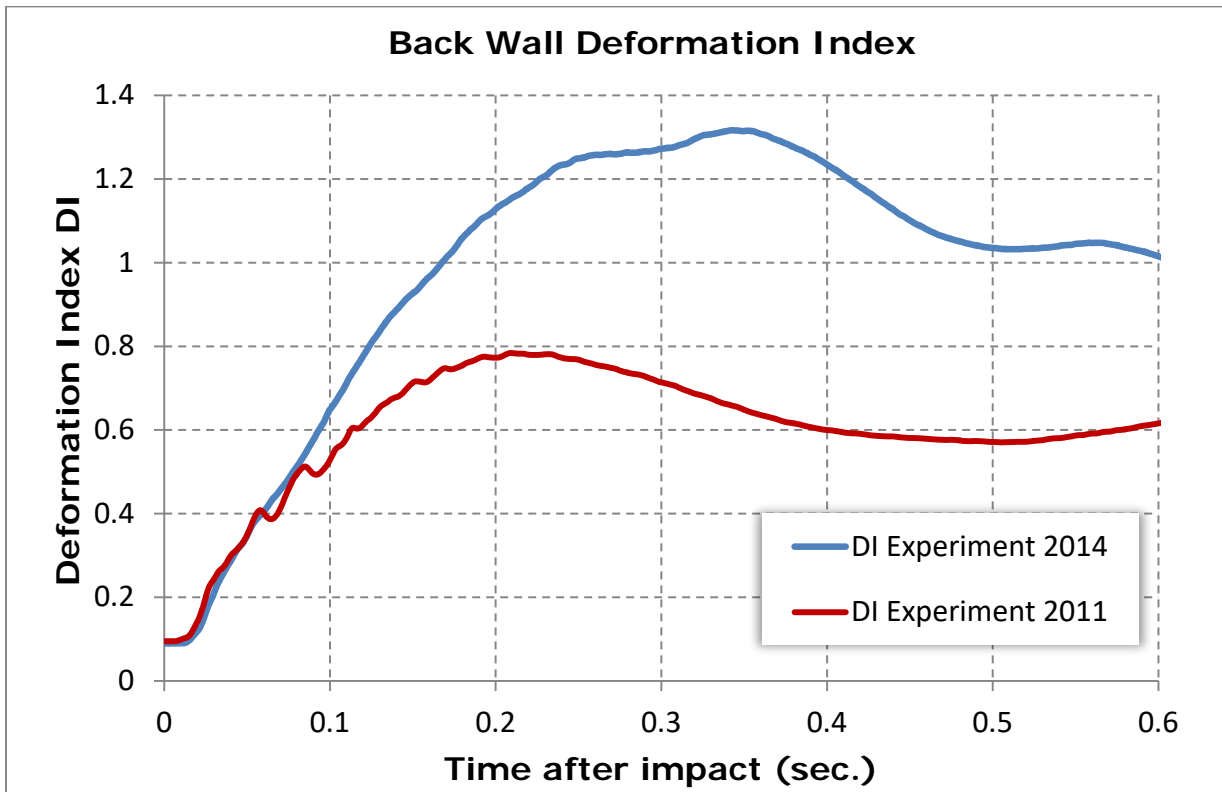
Figure 7.4. Back wall deformation index versus time.

The results for the back wall structure of the bus, however, differ substantially from what was predicted by the FE simulation and from the 2011 rollover. As can be seen in fig. 7.4 the back wall Deformation Index reaches a maximum value of $DI > 1.3$ indicating substantial intrusion into the residual space and failure of the rollover test.

The relatively poor performance of the 2014 bus back wall when compared with the 2011 test is easily seen in fig. 7.5 which shows both buses at 0.25 seconds after impact. Though it was expected that the back wall might perform slightly worse than the 2011 test due to the stronger front structure, a test failure was not anticipated. In order to determine the reasons for the deviation from the predicted results a post-test analysis was conducted on the bus structure.
